Rotten to the Core

A tricky deck repair is tackled with plywood and epoxy resin **By Connie McBride**

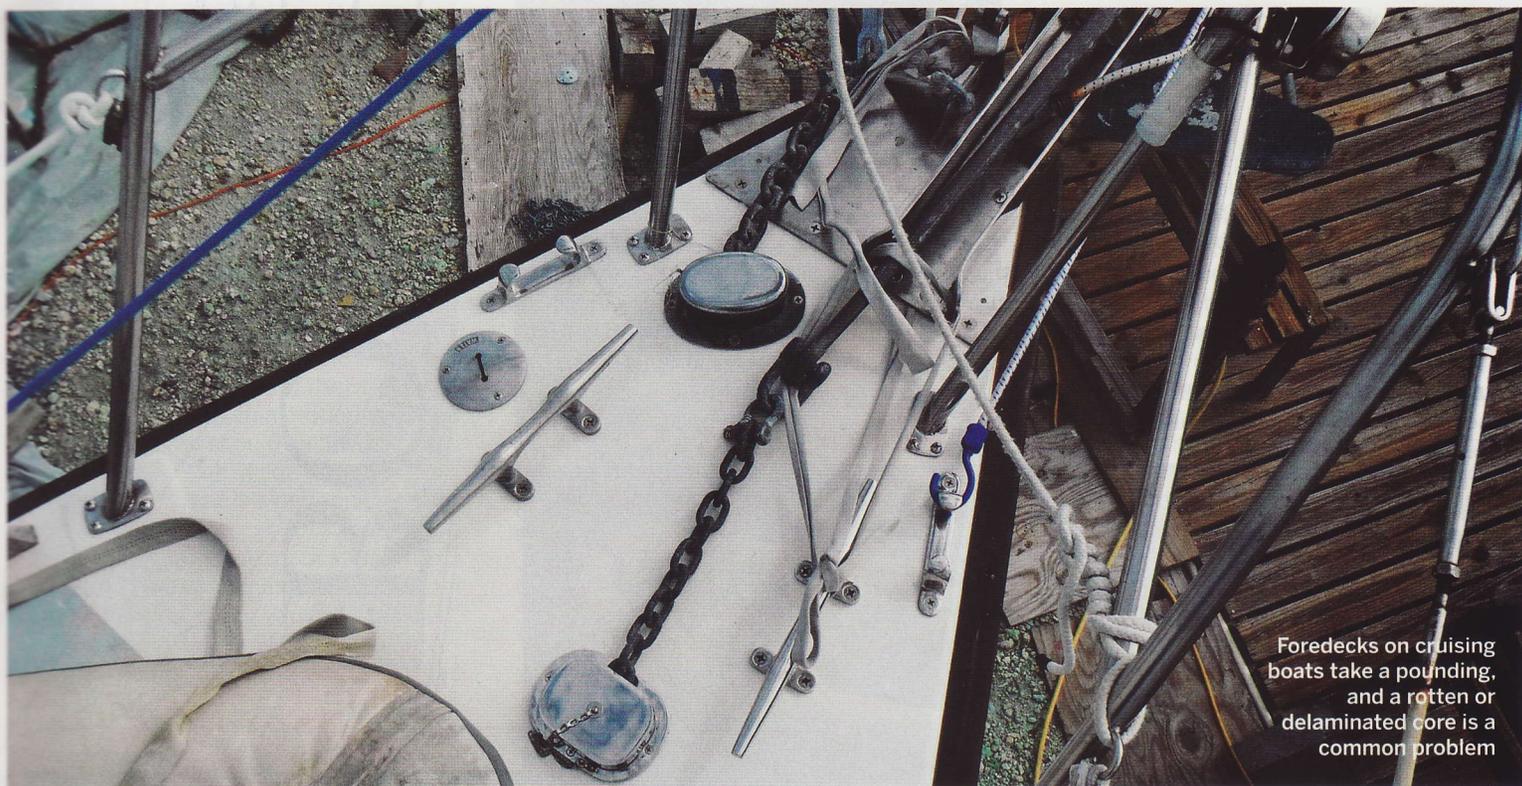
Foredecks on cruising boats take a pounding, and a rotten or delaminated core is a common problem

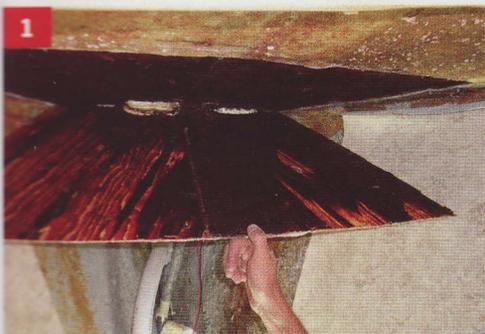
When friends on an Allmand 31 asked my husband, Dave, for advice about repairing cracks in the fiberglass near their bow cleats, Dave realized they had a much bigger problem than mere stress cracks. Upon further inspection, he found that the entire plywood core of the foredeck was rotten. Previous owners had cut holes for the anchor rode to pass through the deck into the

bow locker without waterproofing the exposed edge of the core between the two laminates of fiberglass. The plywood had been reduced to a soggy sponge, no longer supporting the foredeck, which visibly undulated when the anchor rode pulled tight or someone walked on it. Bottom line: the core needed to be replaced.

1 Rotting and delaminated plywood is revealed when the inner skin is cut out

fiberglass would later help support the replacement plywood. The exact size of the lip was not important; go with whatever works best with the existing hardware and the location of the rot. Dave used an oscillating saw with a titanium-coated blade to cut the core and the inside fiberglass laminate. When the interior laminate was cut, it took little effort to peel it off the rotted wooden core.

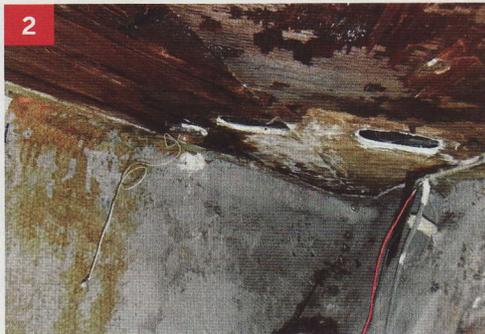
2 The bare patch forward shows where the rotting ply has been scraped away—plenty still to do

With the laminate and the wood removed, Dave next attacked the remaining core between the lip of interior fiberglass and the deck. To remove the rot he broke it into smaller pieces with a chisel, and then used his deck caulking reeving tools (which resemble bent screwdrivers) to clean out these scraps of rotten wood. Once the area to be repaired was completely clear, it was time to build the replacement core.

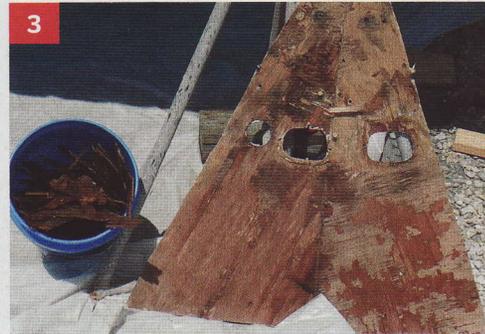
3 Now it's time to scrape the ply remnants off the inner skin

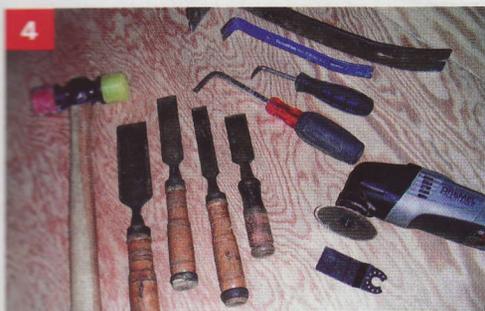
4 Tools of the trade—the bent screwdrivers are ideal for reaching between the fiberglass skins and rooting out rotted core

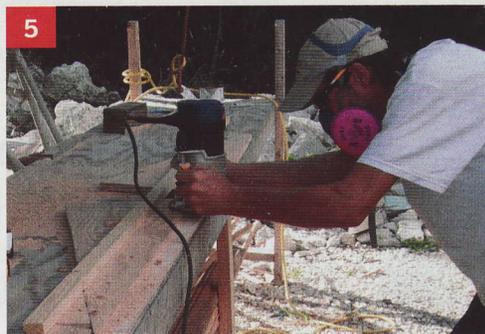
5 Dave fashions the three-piece replacement core from plywood

Using the laminate skin as a template, Dave built the replacement core in three pieces—two triangular side pieces and a trapezoidal middle section—for ease of handling and to help the core conform to any curve in the deck. Because the replacement core was thicker than the space between laminates, he marked off the distance of the overhanging lip of fiberglass and used a router to remove the extra

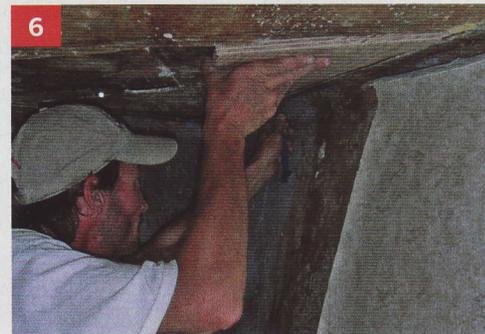
6 It takes trial, but hopefully not error, to ensure a perfect fit

Dave then dry-fitted the port and starboard pieces, marking any spots where he needed to remove additional wood for a tight fit while still leaving enough room for a good epoxy coating on the plywood. When the two side pieces were a perfect fit, he measured the center piece, cut it out of $\frac{3}{4}$ in plywood, and routed the forward end so that it fit under the lip of fiberglass there.

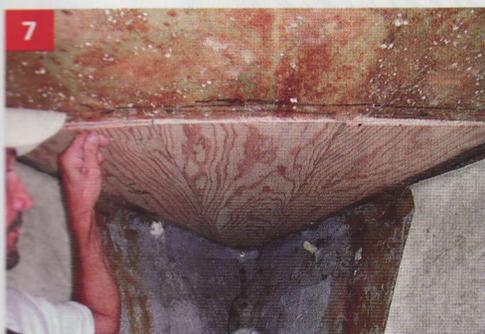
7 The new core stands proud of the laminate; its edges will be trimmed to allow a smooth transition

Using a grinder, Dave tapered the edges of the boards where they met the remaining laminate. This tapered area would make blending the two areas together with fiberglass tape easier later on.

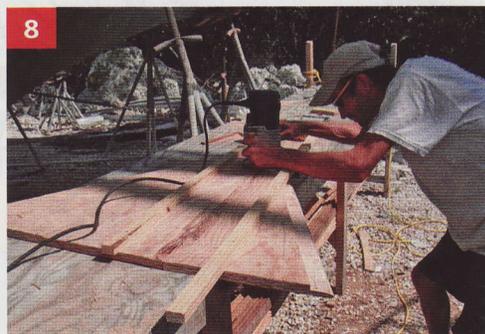
8 Dave uses the router to bevel the edges of the new core pieces to allow for fiberglass tape

Since he also wanted to use 2in fiberglass tape to secure the three boards to each other, he routed out $1\frac{1}{2}$ in on the inside edge of the side boards and both sides of the inner board to accommodate the width and depth of the tape. This would allow the inside laminate to lie over the replaced core without leaving a bulge where the tape was.

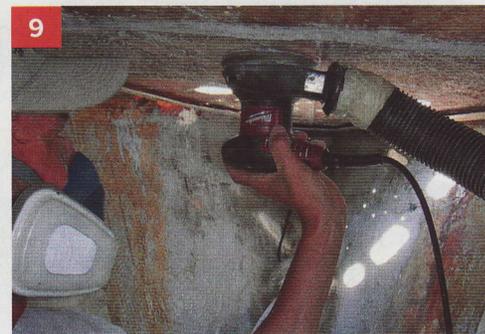
9 The surfaces must be sanded until they are entirely free of old core before the next step

Screening the forepeak off from the rest of the boat with plastic to minimize the mess, Dave taped a shop-vac hose to his sander and sanded every surface that would be epoxied. After wiping down the area with acetone, we were ready to install the new core.

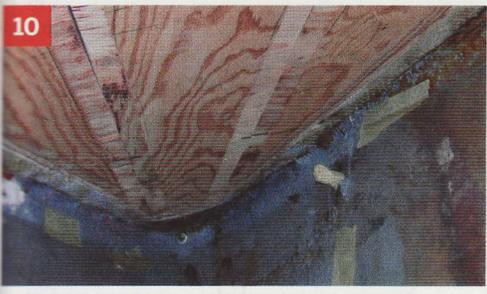
10 After brushing neat epoxy onto the underside of the deck laminate, Dave followed up with thickened epoxy and then tapped the tight-fitting ply pieces into place with a mallet

a chip brush to apply neat (unthickened) epoxy to the plywood and the underside of the outside fiberglass laminate. This prevents the joint from being epoxy-starved when the wood soaks epoxy out of the thickened mixture used for gluing. Next, he used colloidal silica to thicken the epoxy to the consistency of frosting. Using a putty knife, he then pushed this thick mixture into the spaces between the two laminates. He also smeared this thickened epoxy onto the starboard piece, fitted it using a mallet, after which the owner secured it from above with screws, as we had practiced earlier.

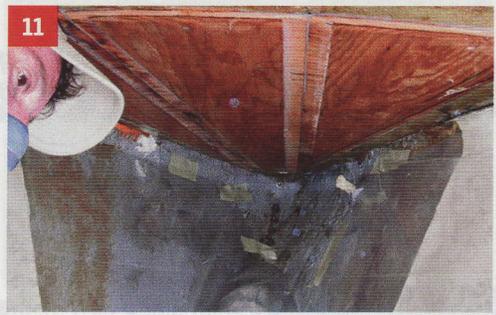
11 Thickened epoxy oozes between the joints and is tidied up before fiberglass tape is applied over the joints

Dave repeated the process on the port side, directing the placement of additional screws as necessary to pull the wood and laminate together to prevent voids. As he did so we were careful not to tighten the screws to the point that all the epoxy was squeezed out, leaving nothing to adhere to the wood and fiberglass. After the middle piece was installed in the same manner, Dave laid two strips of fiberglass tape along the seams where the three pieces joined. Next, he coated the laminate skin with neat and then thickened epoxy and screwed it to the new plywood core. Though he had planned to use fiberglass tape along all four outside edges of the laminate at this time, he decided to wait until this portion had cured.

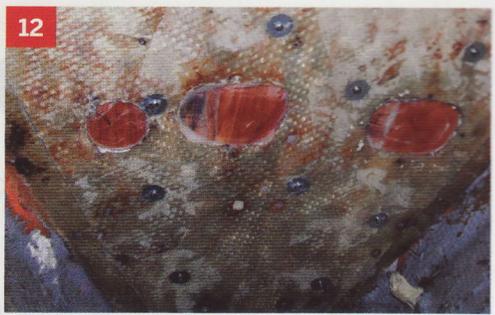
12 The bottom laminate is smeared with epoxy and then offered up—after which it is held in place with screws and washers

we slowed the cure time as much as possible. After that we dry-fitted all three pieces again and screwed several screws with large finish washers into the new core from the outside. Because Dave would be replacing the inside laminate, he could not screw the core in place and it needed to be secured while he completed the installation.

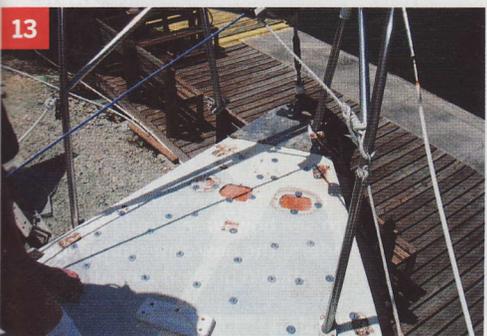
13 Screws and washers are used to draw the new core hard up against the top laminate

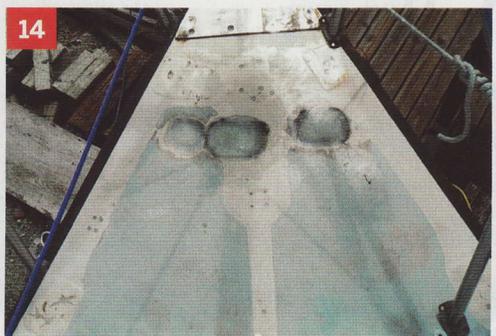
14 After filling in the screw holes, it's time to sand the deck smooth before painting

The next day he removed the screws, sanded down the edges of the inside laminate and epoxied the fiberglass tape to the edges of the laminate. He also squeezed thickened epoxy into the screw holes after countersinking them, after which the foredeck was ready for the hardware to be reinstalled.

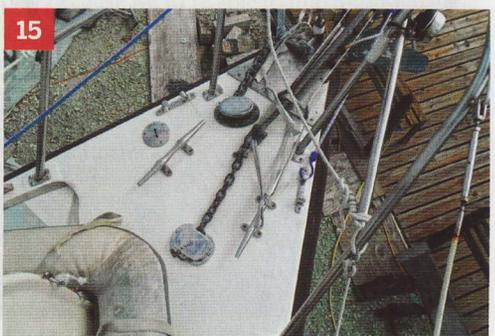
15 The hardware is bolted back on, and the foredeck is good as new

When installing any hardware into a cored deck, it is best to drill an oversized hole and fill it with thickened epoxy. After this has cured, drill the size hole that is necessary to accommodate the hardware installation. This way, there is no exposed wood to allow moisture into the deck. Similarly, if you make a large hole, such as for a hawsepipe, in a plywood deck, coat the exposed wood with epoxy. For a cored deck, scrape out a ring of core from between the two laminates and fill this area with thickened epoxy. With proper treatment, deck laminate penetration will not lead to rot, and you'll never have to worry about replacing the deck core. **S**
